**Degreaser System
Pollution Prevention
Evaluation**

**M.F. SZABO, M.T. NUTTER
PEI ASSOCIATES, INC.
11499 CHESTER ROAD
CINCINNATI, OHIO 45246**

SEPTEMBER 1990

**FINAL REPORT
NOVEMBER 1989 - SEPTEMBER 1990**

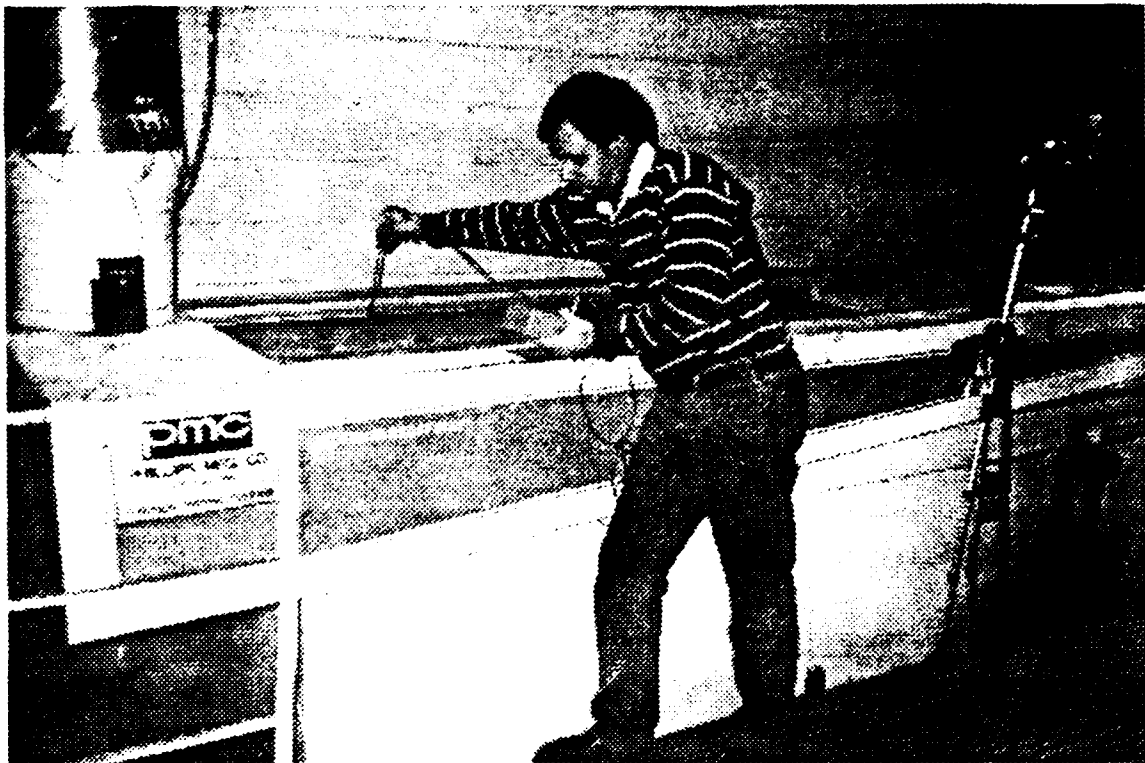
Figure C-6. Air velocity measurement at degreaser lip vent.
